The site of the Polish Church (now demolished), off Manor Road, Whitchurch

Notes made by Sally Woolhouse & Gill Goodwin (WoTHabs) following site visit on 12/04/2017 with Jon Steward & Pete Woolhouse

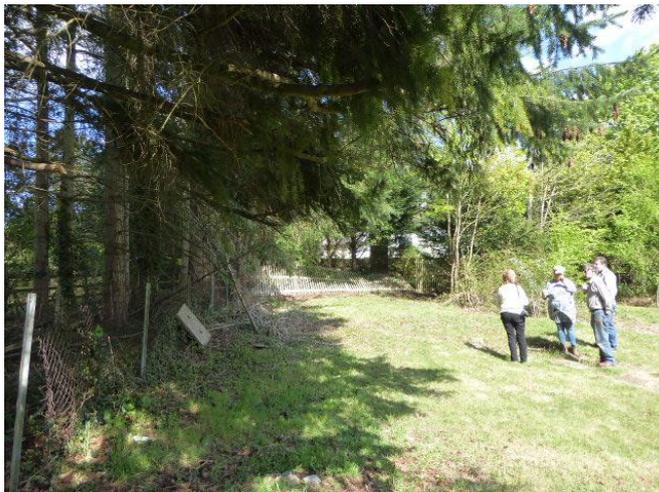
1) Row of fir trees on boundary

Jon explained that a tree surgeon had been invited to quote for clearing the lower branches on these trees to a height of 6m. We decided that this was unnecessarily radical (and an avoidable cost) and all that was required was the removal of only the **dead** lower branches, with clean cuts flush with the trunks and possibly a few really low live branches that might catch people in the eye. Visually we felt this would be a more sympathetic approach. The ivy growing up into the trees should be cut off at ground level.

Jon agreed to carry out this task. The dead wood would be neatly laid along under the base of the trees (near the far Coombe park boundary wooden fence, to provide refuges for small mammals and invertebrates).

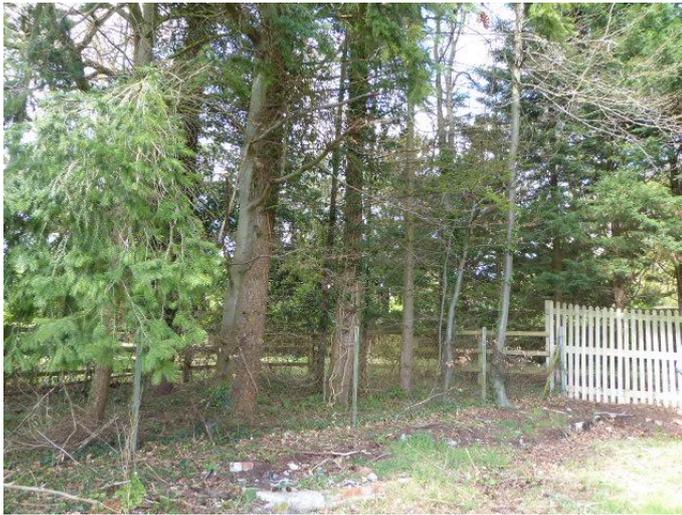
3) Small beech trees in the chain link fence at N end

There are 3 small beech trees, which may have originally been planted as hedging (or are overgrown seedlings) which have grown up into the firs and are interfering with the trees surrounding. We agreed that these should be cut down at least to fence height or alternatively, to ground level (if more practical). They should not be allowed to re-grow higher than fence height in future.

Jon agreed to fell these as soon as possible; the trunks and thicker branches to be stacked in one place for taking away for firewood and the brash should be laid under the firs (as in (1)).

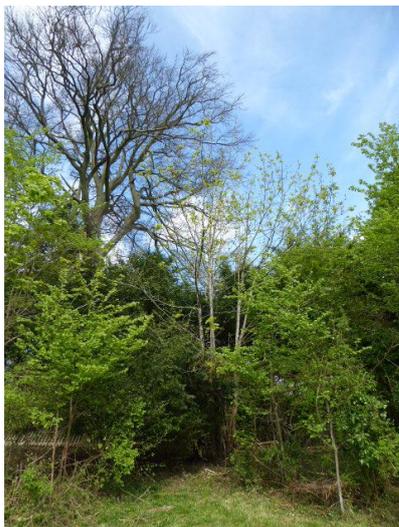
4) Group of small trees

There is a group of 3 small trees at the west end of the spinney (see photo) consisting of an elm and 2 sycamores, (Marked with a red cross on the map below). They are all in poor condition and should be felled.

Jon agreed to do this, separating the resulting timber as in (3), except that Pete requested that the trunk of the elm be kept in long lengths, because it is useful straight timber for fence posts or other purposes.

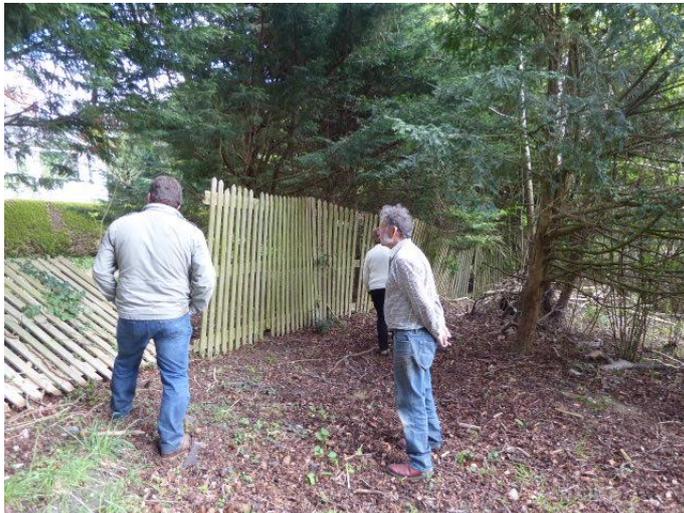
5) Multi-stemmed sycamore

There is a medium-sized sycamore, probably coppiced in the past, which should also be felled (behind yew in photo below). It is close to the yew tree, to the SE. (Marked with a red cross on the map below). Jon agreed to do this, separating the resulting timber as in (3).

(Note: we agreed that no sycamore should be allowed to grow on the site at all because they will eventually get too big and overbearing).

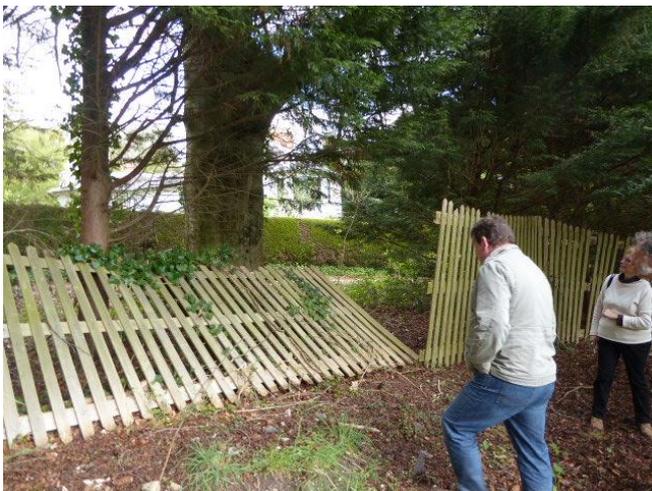
9) The tall panel fence on the N boundary

This fence belongs to Coombe Park and it has been taken down in the past to gain easier access for the removal of the church building. At present it is still part standing but repairable.

Although it looks unsightly, it is probably a good idea to leave it as it is until the fencing work, firewood removal and possibly wood chippings for pathways are completed. If Jon can arrange with the appropriate person to get permission for temporary access, that would save a lot of wheelbarrow work.

Pete has agreed to properly repair this fence when appropriate.
